## Environmental Problems Generated by Capillarity - Deteriorate Relationship in Buildings of the Lower Area of the Historic Centre of Santiago de Cuba

MSc. Ing. Mayelin González Trujillo<sup>1</sup>, Dr. Eduardo Beira Fontain<sup>2</sup>, Dra. Odalys Alvarez Rodríguez<sup>3</sup>  
& Ing. Liber Galbán Rodríguez<sup>4</sup>

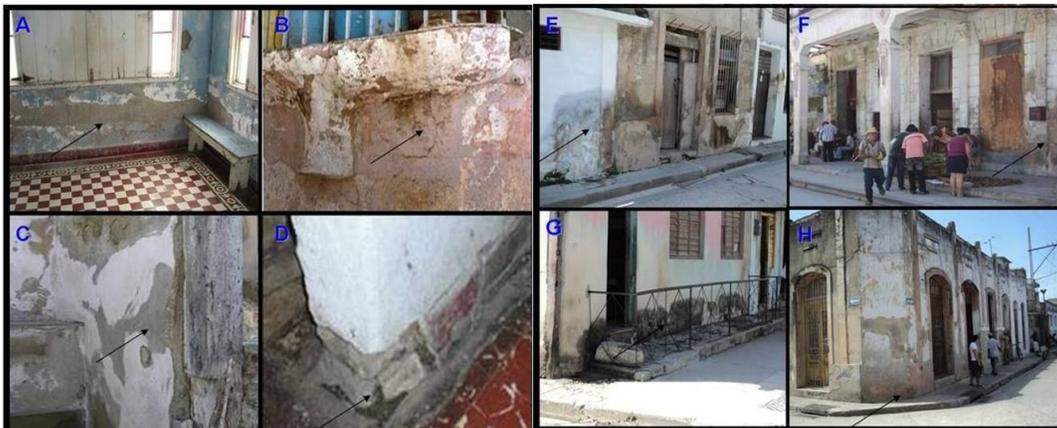
**Figura 3: Attack of the Capillarity Humidity in Buildings of the Study Area. A, C y D: Inside Houses Locations; B, E, F, G y H: Facades**

As you can see the deterioration of buildings is critical and the appearance of the lesion is common in batches with high capillary heights. Figure 3 shows images of the state of the buildings in this area by capillarity humidity attack.

Such is the case in the study area, that in order to avoid the high economic cost of necessary repairs or simply through ignorance, in homes affected by the humidity, we have tried to cover them with new plaster or with various coatings.

These are "makeup", which only serve to temporarily hide. The moisture and fungi present state will continue and is likely to produce new exposures in the wall at a level above. This results in an attempt to waterproof the walls and the surface. In the best case is achieved by temporarily hiding moisture, but the real result is none other than the 'chimney effect' that raises even more moisture through the wall. This does not solve the problem but worsens and becomes more expensive the solution for the need to re-address the situation.

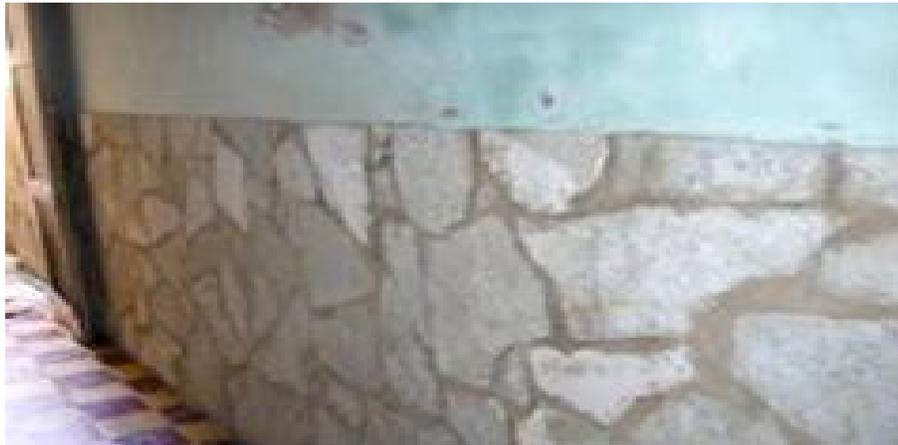
**Figure 4: Flagstone Veneer Buildings in the Historic Center Santiago. Note the Capillary Phenomenon over the Slabs**

From a cognitive standpoint, the wrong and inadequate behavior and management of the resident persist, related to the treatment of the buildings injuries caused by the humidity-capillarity phenomenon. Instead to solve the problem, they worsened the situation using inappropriate reparations techniques that in place to decrease the deterioration condition increase the manifestation of the capillarity. For example, there is a famous technique frequent using by the residents that consist in a "flagstone veneer", (see Figure 4).

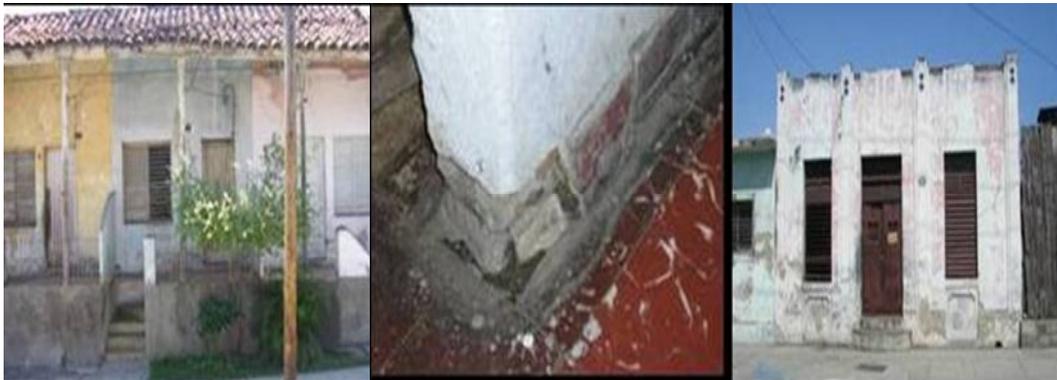
**Figure 5: Deterioration in Facades and Walls of Buildings in the Historic Center Santiago**

The construction materials frequently used of these buildings are naturally absorbent and porous, as in the case of masonry, ie (solid brick, hollow brick, natural stone, etc.). Enlucidos plaster or cement, which may have impaired due to water absorption, which leads to the formation of salts, mosses and efflorescence. These events in turn cause dimensional changes in the components, causing cracks and fissures parallel vertical and located in areas with easy wetting and drying continues (starts foundation with damp hair and coronations bit protected facades). On the walls there are stains, includes painting and finally begin to discard the plaster or coatings (see Figure 5).

The main contradiction in this section is the construction technique and materials used, and other materials that could be applied more resistant to water or other construction techniques according to the situation.
