## An Architectural Assessment on Twin Type Official House of Jatiroto Sugar Factory Jatirotoin Lumajang District

The complex of Jatiroto Sugar Factory is an area of sugar processing industry which has an old building that still survived until recently. The area of official house an interesting part of this sugar factory complex to be further investigated. The official house building of Jatiroto Sugar Factory is almost 100 years old with a fascinating style. The one of building type is the house with twin type. The twin type house building valued based on its architectural quality by using cultural significance valuation on the building. The aim of this research to find the value of twin type official house building which could be a direction for building preservation, then this building could be maintained its originality. The research method is descriptive evaluative method which would be employed on visual and spatial elements of building. The research result an architectural assessment from the twin type official house of Jatiroto Sugar Factory, Lumajang District, which produces a moderate average value so that routine maintenance and maintenance are required, as well as repla

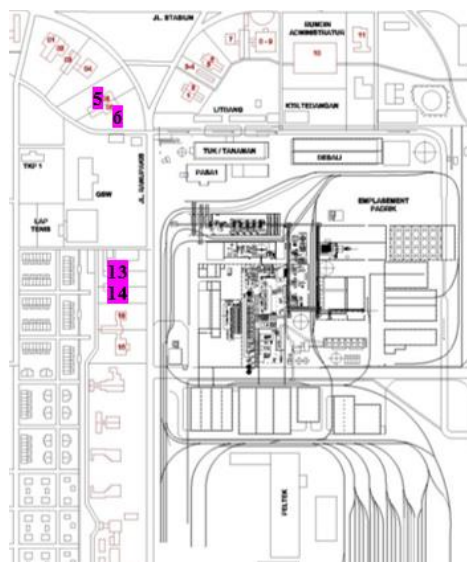
Figure 1. House layout in Jatiroto Sugar Factory, Ranupakis Street.  
Source: (Vembrista, 2017)

This research focused on the twin type official house building which located in the area of Jatiroto Sugar factory. (Figure 1) There two houses which have twin type; the houses addressed on 5<sup>th</sup> and 6<sup>th</sup> Ranupakis Street and another house on 13<sup>th</sup> and 14<sup>th</sup> of the same street. To collect the data, the observation is done directly in the research area to see the physical condition of building. (Figure 2, Figure 3, and Figure 4)

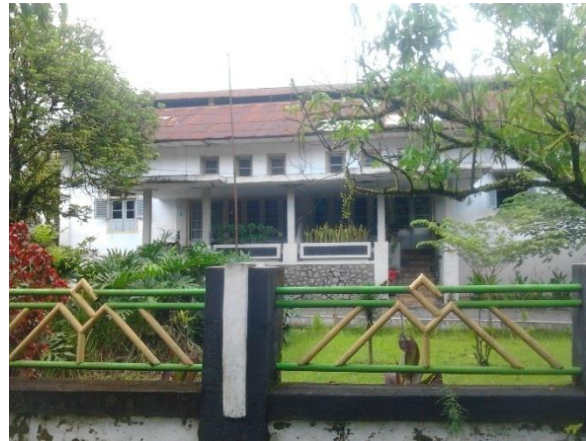
Figure 2. House image, 5<sup>th</sup> and 6<sup>th</sup>Ranupakis Street.

The first house is a house which addressed on 5<sup>th</sup> and 6<sup>th</sup>Ranupakis Street. This house is in twin type building which could be seen from the building façade. Generally, the house shape dominated by rectangle shape on the blueprint and triangular on the front part. The blueprint or front of first house building is symmetrical. The room arrangement inside the building also split into sides and equal proportion. The symmetrical building could be identified by drawing a vertical line on the blueprint. The total space on whole building mass is 30 rooms. Furthermore, the building orientation directed to northeast.

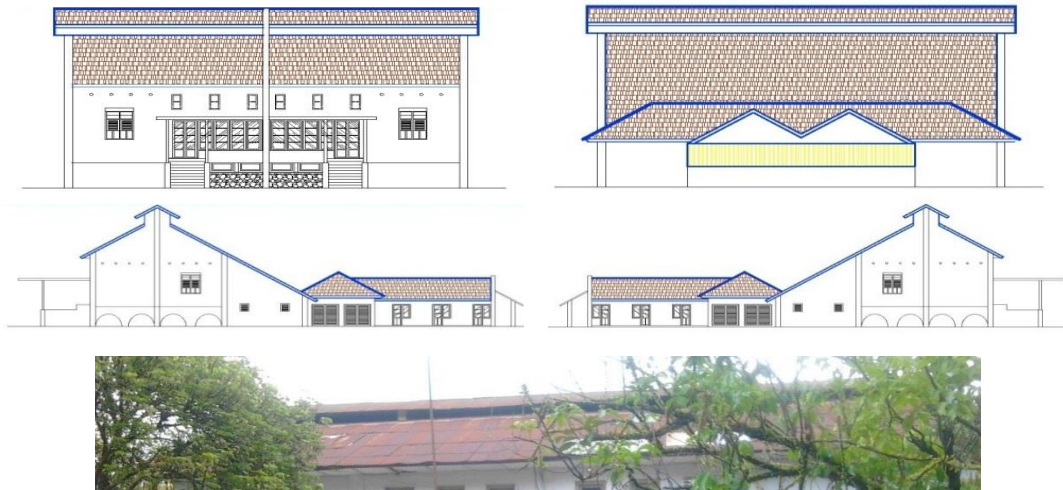
Figure 5. Roof shape of first housespace.

The building roof is in saddle shape and ground tile material. On the front area of building, the saddle roof got a level difference, so the smaller saddle roof was positioned on the upper part which would affect to stacked roof. On the garage area, the roof is in shield shape, while the back area in saddle shape roof the roof has declivity level of 40°. (Figure 5)

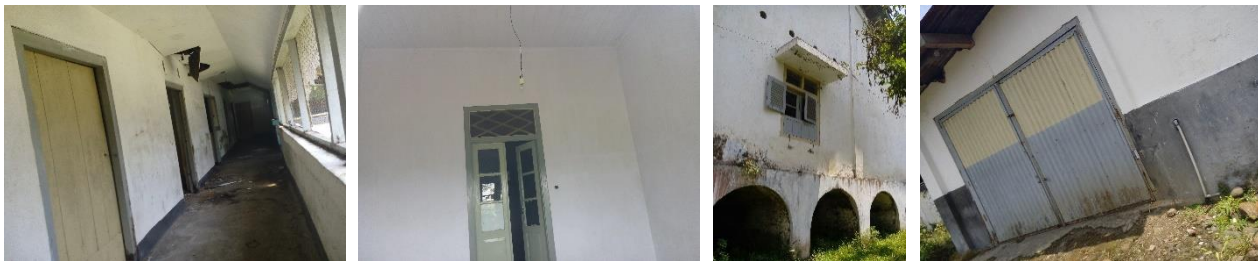
Figure 6. Door and window shape of first house.

The wall became a room divider which exerted brick wall and door as the connector among the rooms. The door made from wooden and glass material. The door with ornament is in a hollow rectangle and inverted diagonal trellis decoration. The window in first house has seven types of window with wooden and glass material. (Figure 6)

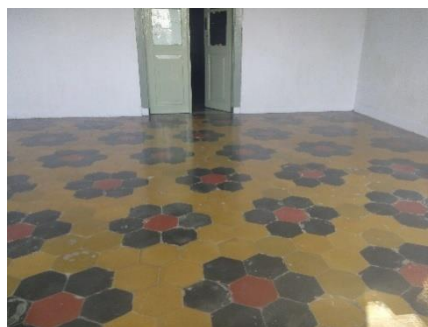
Figure 7. Floor pattern shape of first house.

The floor made from hexagonal tile materials with dimension of 20cm x 20cm. the hexagonal tile arranged to resemble flowers with different colors, which raised the ornament effect on the floor pattern. The column in front porch of house used cast concrete material with dimension of 30cm at the bottom and 15cm at the top part. The height of column is approximately 4.6m. (Figure 7)

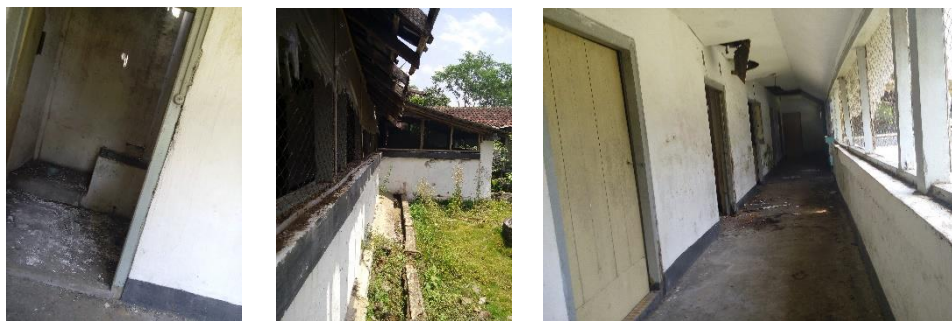
Figure 8. Building decay of first house.

The architectural mean vale on first house 14,9, thus, it referred to the medium potential assessment of preservation. The result of medium architectural assessment would enable the building to get a medium change or renovation, so the building did not change wholly. The damaged part should only be restored. The damage level of first house in the part of building elements as wall and roof parts. The bottom part of wall is old and discolored. The most of wall and roof parts collapsed and crumbled. (Figure 8)

The medium potential assessment was categorized into conservation or rehabilitation. The level of physical renovation which allowed in this assessment is medium category. Visually, the roof and wall part of building showed the high score to have renovation by painting in original similar color. The hollowed roof part is replaced by new material plafond with the color of original building. The floor, door, and window needed to a periodic maintenance by cleaning up regularly and painting the moldy part. If the door and window broken, they should be replaced by the new material which could resemble the original material. The original material made from wood, so it could be maintained by varnish coating in order to make the durable door and window, and the last step was repainting.

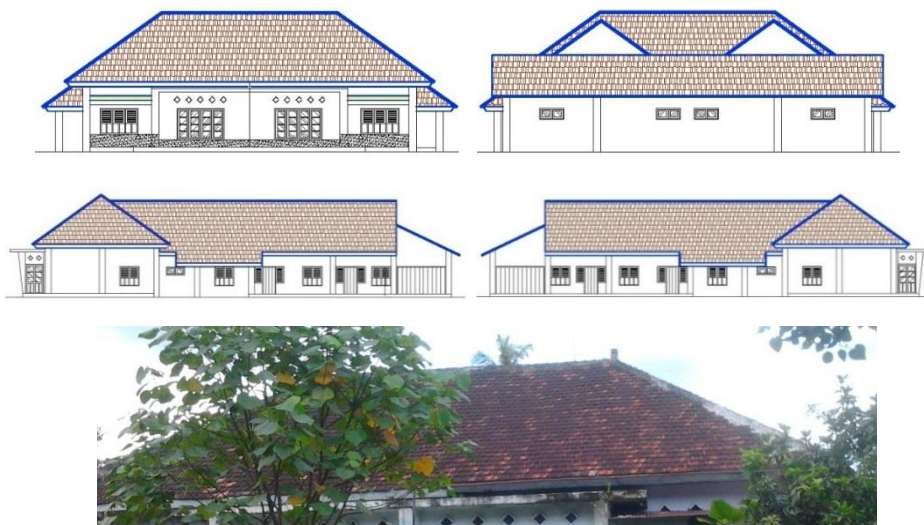
Figure 9. Roof shape of second house.

The second house a twin type house building which could be identified from the front building appearance. Commonly, the shape of house is dominated with rectangle shape on the blueprint, and triangular on the exterior. The blueprint or exterior of second house is symmetrical. The room arrangement inside building is also split and equally proportion. The building orientation headed to east. The total room in these second house 15 rooms on a single building mass, so the total space are 30 rooms on two building masses. (Figure 9)

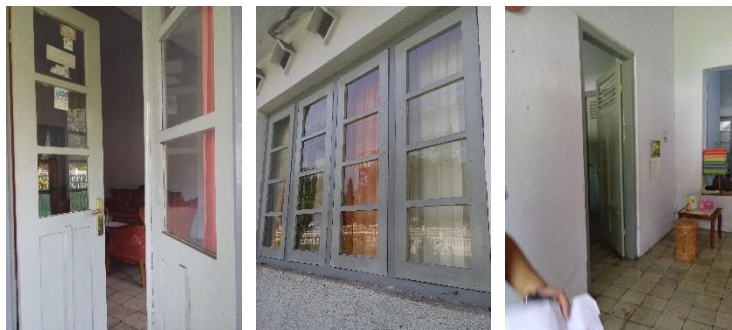
Figure 10. Door and window shape of second house.

The wall is a divider between rooms which used brick wall and door as the connector between rooms. The door made from wooden and glass material with the total of six door types. The window of second house has nine types which made from wooden and glass material. The certain window is also in *jalousi* model. The floor made from tile material with dimension of 20cm x 20cm. The building ornament on porch area made from cast concrete material. (Figure 10)

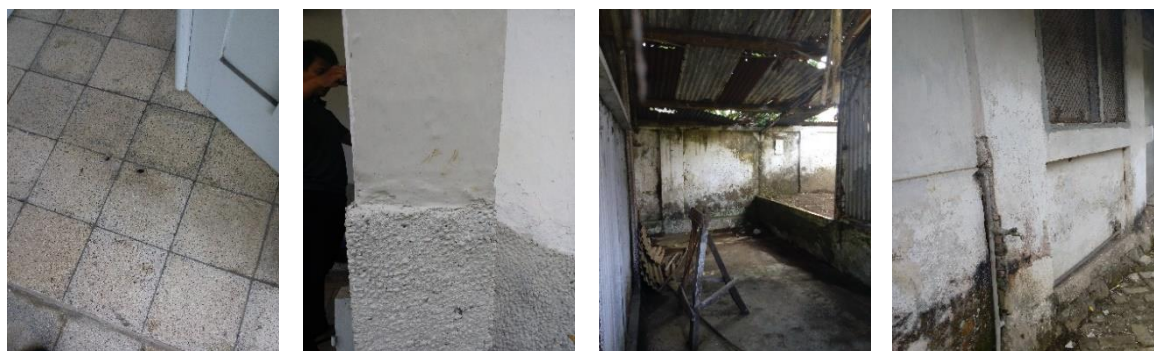
Figure 11. Building decay of second house.

The architectural mean value on second house 14,3, thus, it referred to a medium potential assessment of preservation. The medium assessment affected the second house to deserve the medium renovation level. The building parts which must be renovated were collapsed and crumbles roof. The wall part must be cleaned. Moreover, the element of door and window is still in a good condition. (Figure 11)
